Kelso Service Bulletin # KTUD1500

September 15, 2015

Subject: Corrosion Guidelines of Carbon Steel Flanges

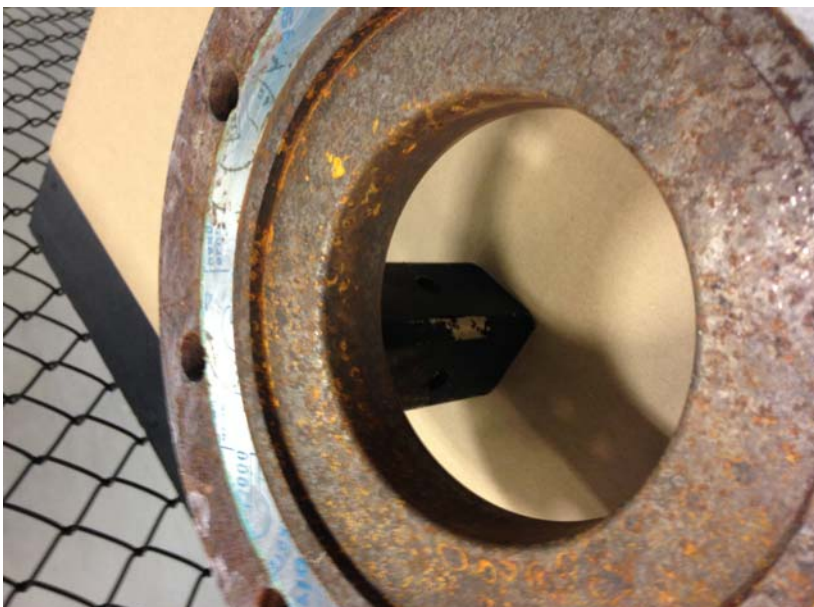
Flange after being
in service

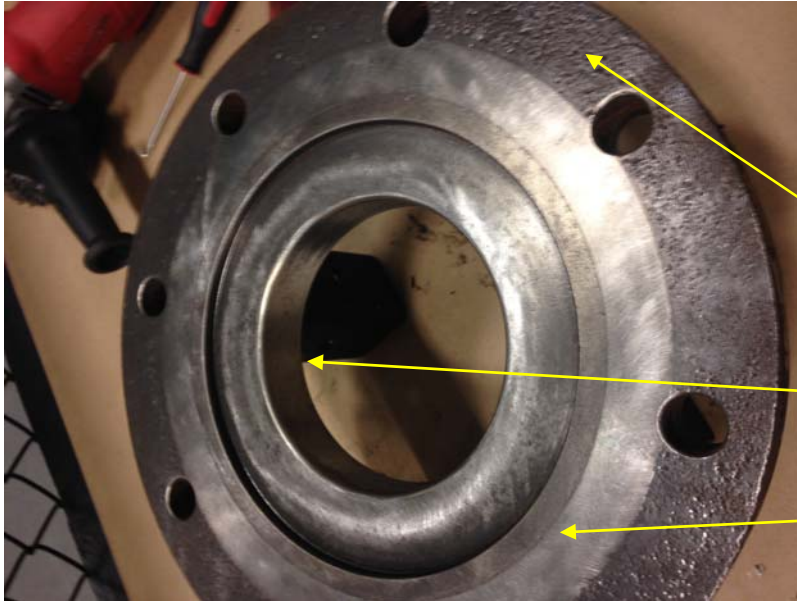
Flange after blasting and properly cleaned

Allowed degree of pitting in non-critical areas

Valve Seat Area

Gasket Surface

- After having flange blasted to remove excess rust, the flange can be inspected for excess of pitting, specifically on the valve seat and gasket surface. These areas must be free of scratches, gouges, pitting, dents, etc. Such conditions will make valve leak.
- Some valve flanges are designed for a tongue and grooved and raised faced connections. In such case, the same guidelines apply.
- The use of Emery paper (400 grit) is permitted to clean and buff the seat of the valve and flat face gasket surface for minor dings and scratches.

- Some pitting can be tolerated in non-critical areas. If pitting is more than .030" in non-critical areas, contact Kelso for guidance.
- After blasting and cleaning valve, the entire flange can be wiped down with soybean oil base coat or inert oil base solution. Especial attention should be exercise as some commodities will not tolerate some of these solutions. Contact Kelso for assistance.

- In the event, that excessive pitting or damage is noticed on valve seat and gasket surfaces; flanges may be re-machined/re-conditioned and put back into service. Contact Kelso for assistance.
